NTCA – Devon Street West Cycle Route Audit

8 September 2007

1.3 Devon Street West Cycle Audit

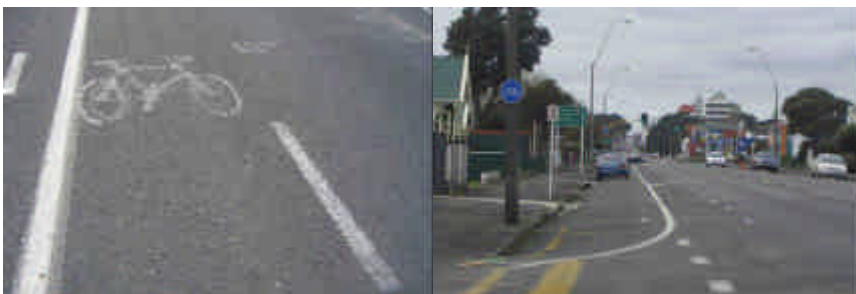
Furthermore, a recent contractor road marking exercise did not re-paint much of the existing cycleway lines, which in my opinion was a missed opportunity. I have noticed this trend with the contractor not re-painting cycle lanes and stencils throughout my riding in New Plymouth. I wonder what their scope of work is... to repaint all lines on roads or to repaint only the lines “they” feel need repainting. In the bright sunlight, lines can appear adequate but in the dusk in the rain, their effectiveness is significantly reduced. For example, this cycle and lane marking (right line), on Devon Street heading east at Belt Road (the real start of the cycle route). Note in the second photo how the faded cycle stencil blends into the colour of the pavement and disappears for the drivers. This often happens for the non re-painted dashed cycle lane markings. At the left hand side of this photo is one of only two cycle route marker in either direction on my commute. It shouldn’t be too expensive to add more signs and road markings?

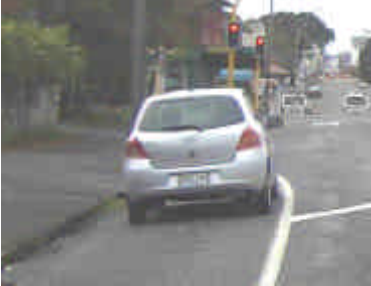
However, some of the pavement has been so built up over the years that a significant wheel-width 'ditch' exists along much of the route (see photo). This causes motorists to park farther away from the kerb and in some cases infringe on the cycle lane or cycling space.

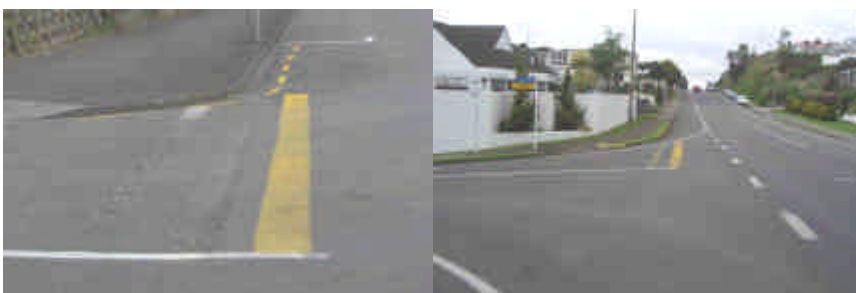
Additionally, the painted stop/yield lines on the majority of the intersections on this route are very close to the cycle route. In some cases, as shown in the photo below of westbound at the intersection of Mt Edgecombe Street, the contractor appears to have ignored the existing lines and moved the stop line forward 0.5-1m. As many motorists overshoot such lines, particularly at yield signs, this makes for either a dangerous situation for cyclists or a perception by the timid cyclist that the motorist is not going to stop. Some of my close calls have been at such locations as motorists are focused on getting through the intersection without hitting a car, and seem to have no awareness of the possibility of cyclists. Strangely, the re-marking contractor has painted the furthest lines and not the back lines, again perhaps encouraging the motorist to infringe upon the cyclist space.

The second photo, taken travelling eastbound at Calvert Road, is an example of the typically significant distance between stop signs and the stop lines. In other countries, the stop/yield line is perpendicular to the stop sign. The law requires one to stop/yield at the sign and then slowly move forward until you can safely see that the way is clear. This method increases the probability that a cyclist (or pedestrian) will be sighted. Another benefit and often law, is that pedestrians have the right of way at these intersections and the driver must allow them to pass. I have actually almost been hit by a car walking across such an intersection naively unaware that a turning driver will not stop for me.

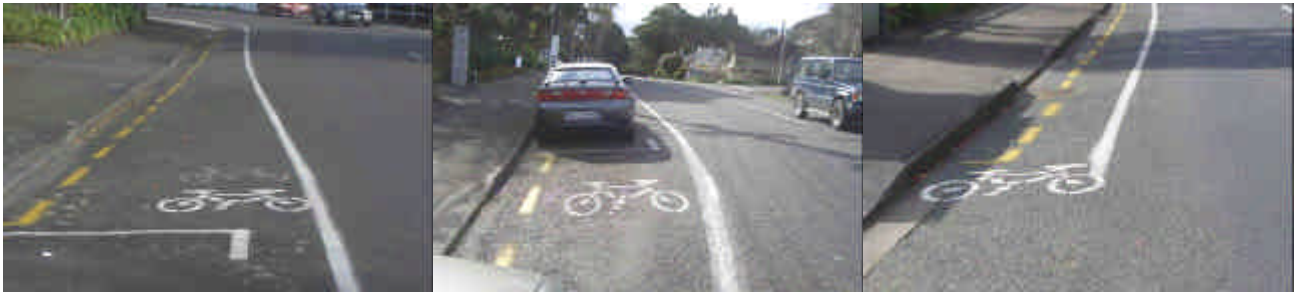
The Carrington Road cycle route has some very good examples of road marking where there is inadequate width for a "standard" cycle lane but where driving and parking motorist awareness of cyclists is increased (see photos below). I have driven that route, seen those markings and realised that adequate room for cyclists is difficult and have increased my vigilance. Note also that the contractor has re-painted the fading markings on this route.

I believe that there are locations on my Devon Street West commute where such marking strategies could be employed. There are also many many locations on my route where parking sizes could be reduced or marked and cycle lanes and cycle stencils could be marked to dramatically increase motorist awareness. I will note these areas in the following detailed audit.

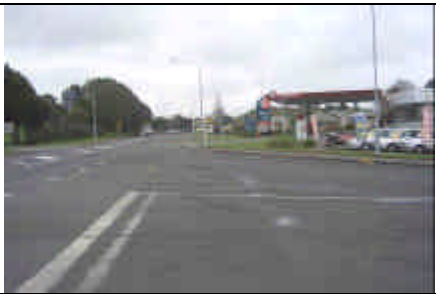
Location	Comments	Photos
Pioneer Road Junction	This is mainly a road shoulder route with lots of room for a cycle lane to be created. The dashed line across the intersection contains the traffic and leaves lots of room for cyclists. Note also how far into the main road the lines are painted (this occurs frequently, and will not be repeated here).

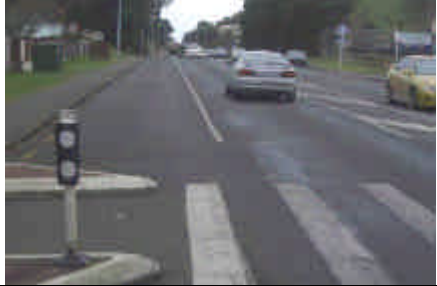
Location	Comments	Photos
Pedestrian Crossing at Spotswood College	Note how the pedestrian crossing start “kerbing” protrudes into the cycling area. Sometimes vehicles travel too close to me and I have veered towards this curbing. I am nervous that I might hit a pedal on the kerbing and have an accident. This should be considered when planning cycle routes and pedestrian crossings.

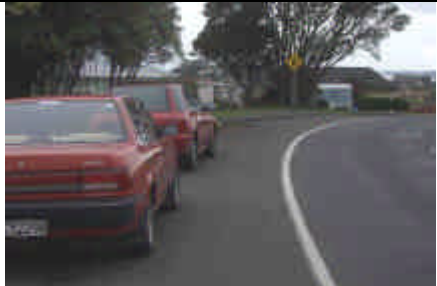
South Road east heading towards the intersection with South Road/Devon Street West	Note the distance between the parked cars and the road marking. There is lots of room for a cycle lane. Parking space marking would also increase the chance that the parked cars would stay near the kerb.

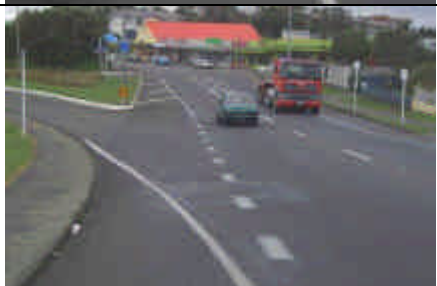
South Road/Devon Street West intersection	This intersection is particularly hairy for cyclists (and pedestrians) as motorists, unaware of their presence, merge left onto South Road. A cycle lane marked through this intersection and increased cycle marking/awareness at this intersection would improve safety.

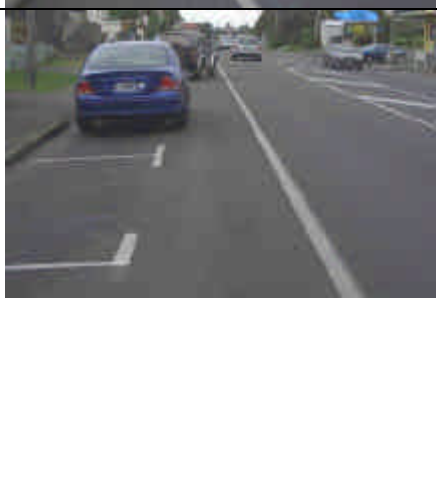
Devon Street West (across from Blagdon shops)	<p>Biking past here can be quite crazy as inattentive motorists often park badly or far right, run across to the shops without looking for cyclists and then pull out without looking for cyclists. I have had close calls with car doors, people running across and cars pulling out unexpectedly. (There has been a recent incident where a vehicle pulled out and a cyclist has crashed into the side of the car and gone over the bonnet. The driver is currently being prosecuted).</p> <p>I am not sure what could be done to improve this but do think that improved motorist awareness with road signs and painted cycles on the road would help.</p> <p>Note also at this location that there is essentially a cycle lane; it's just not fully marked. It would be quite simple to add lane painting here.</p>

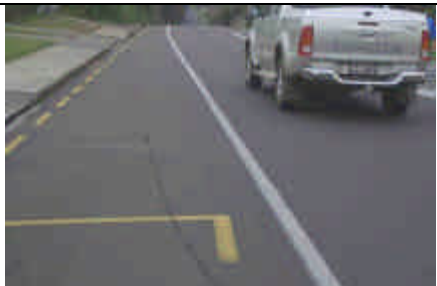
Devon Street West (just past Blagdon shops)	Note how the bus rectangle pinches the ‘cycle’ lane. It would be good if the bus lines were repainted so that the cyclist has at least a metre to pull to the left.

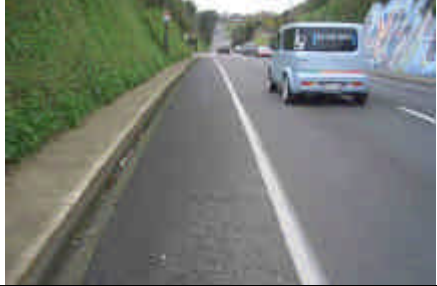
Location	Comments	Photos
Devon Street West (just before Bayly Road)	Note how there is very little room for cars to park here, but they do, and then there is no room for cycles. Perhaps, some of this area could be cycles only as there shouldn't be too much need for on street parking here? This comment applies to the other side of the road as well.

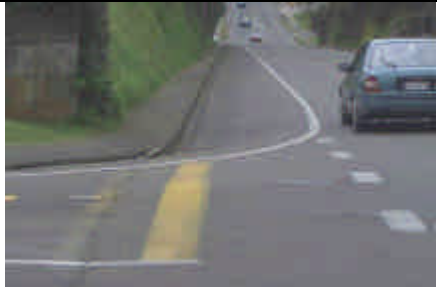
Bayly Road Intersection	Same comment as above. Also, note the far forward yellow line and the lack of re-painting on the leftmost line.

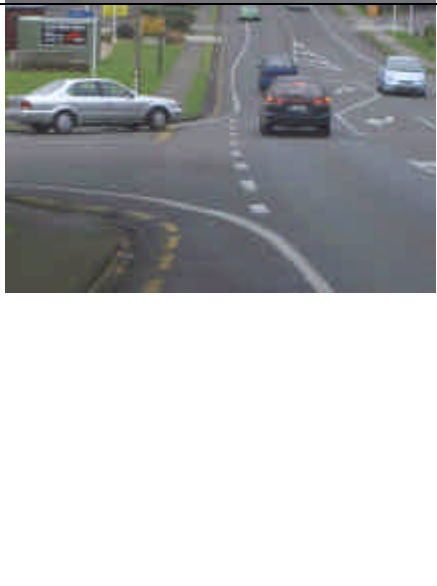
Lawry (Seaview) Road Intersection	Coming down this hill you can really get up some speed. Unfortunately, this is a busy intersection and cars turning onto Devon or from Devon onto Lawry often don't see cyclists, especially when they have turned from Seaview onto Devon and are in a rush to turn onto Lawry. Note also how the car on Lawry has overshot the lines waiting to turn. I come down this hill with brakes primed. A further problem is the complete lack of cycle space on the other side of the intersection. I would assume that motorist safety and traffic flow in adding the turning lanes sacrificed some cyclist space. My caution at this intersection causes me to hit the uphill section beyond at a slower speed than I could/should be going and I have a tough time getting up the hill. If motorist awareness of cyclists here was improved perhaps cyclists would get up the hill faster and more would perceive the route to be easier and more would take their bikes.

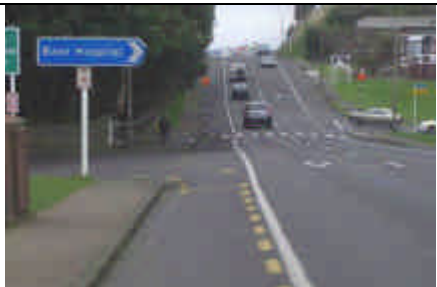
Devon Intermediate and Lorna Street Intersection	This is a crazy area in the mornings with cars stopping, opening doors and pulling out without cycle awareness. There is no cycle lane here. Improved signage and marking would be helpful. I understand that a pedestrian/cyclist underpass is planned at this location and I hope that improving the intersection for schoolchildren includes cyclists' needs on Devon street.

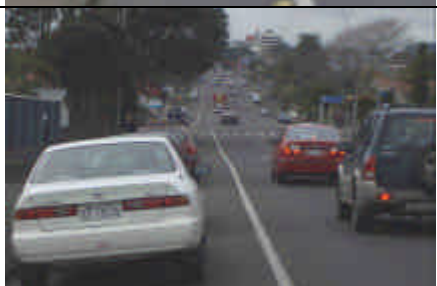
Approach to Pedestrian Crossing at Belt Road	Note adequate room for cycle lane, if car parking area and lane were narrowed.

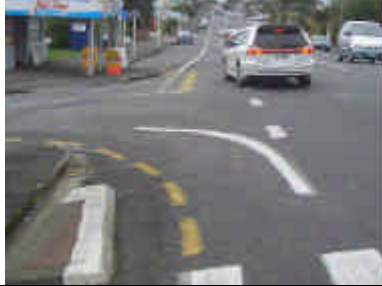
Location	Comments	Photos
Pedestrian Crossing at Belt Road and Start of real Cycle Lane	This crossing kerbing at Belt Road is a much safer design for cyclists. Note how the cycle route sign beyond the tip top awning fades into the background due to the other visual information at that location and motorists are unlikely to see it. In fact I did not notice it during my audit and only saw it upon reviewing the photos. Note also how the dashed line through the intersection helps motorists stay out of the cycle lane.

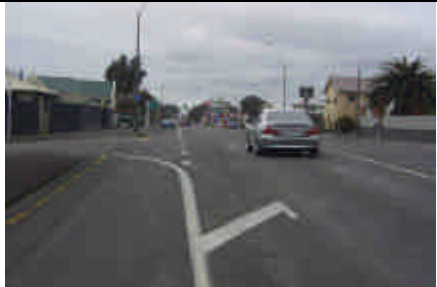
Cutfield Road Intersection	The road marking is confusing here. There is no dashed line across the intersection helping mark the cycle lane as in the previous photo. I am also unsure what the half chevrons in the cycle lane mean. <i>Further research indicates that they might be advising motorists not to drive in this area but I don't think this is clear to most and is inconsistent with other cycle lane marking in New Plymouth.</i>

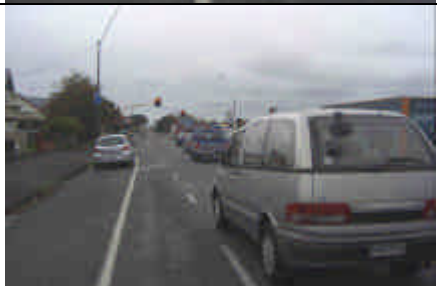
Morley Street Intersection	The cycle lane just ends here before the intersection. There is no indication to cyclists or motorists that the cyclists are meant to turn right to join the cycle lane on the one way system. Cyclists going straight are at risk from cars turning left.

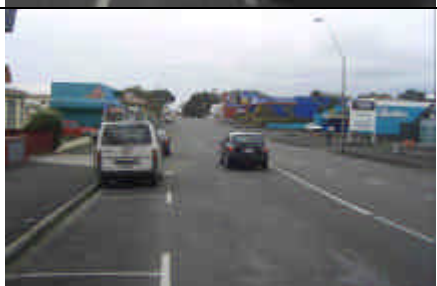
Just past Morley Street	There is lots of room in this part of the road to continue the cycle lane. In fact, as the Morley intersection is so hairy, it might be safer to route cyclists past Morley to turn right on Dawson and then onto the one way system.

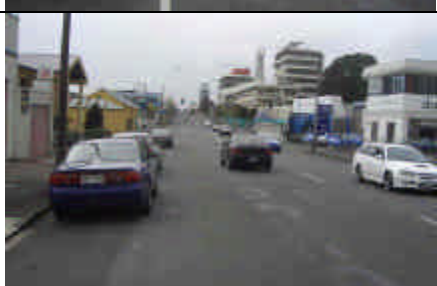
Approaching Dawson	Again, lots of room for a cycle lane here. Recently parking lines have been painted. The Dawson Street intersection is tricky as the lights are fast cycling and it can be hard to judge your speed to ensure you go through on green. Also left turning cars are often unaware of cyclists and it can be hairy to ride straight through.

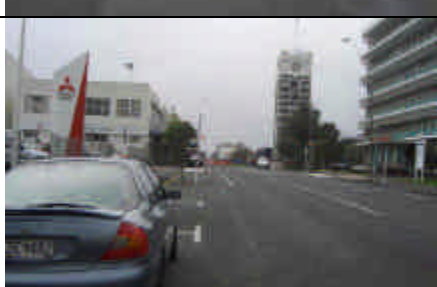
Just past Dawson Street	Continue cycle lane.

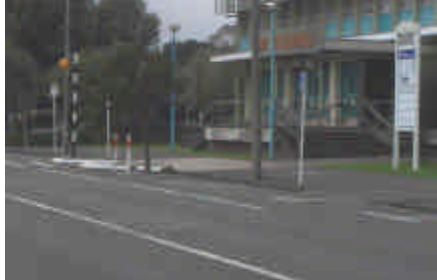
Location	Comments	Photos
Atkinson Building	My destination. Where my employer has kindly provided a bike locker room for safe storage of bikes and gear.

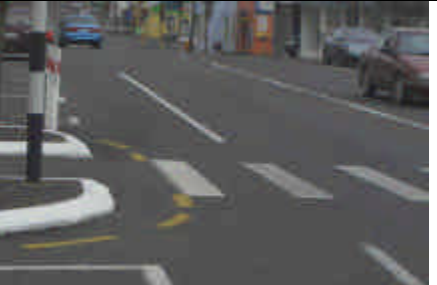
Location	Comments	Photos
Pedestrian Crossing at Atkinson Building.	Note the room between the road lane marking and the 'safe haven' for bicycles. Note also that there is lots of room here for a cycle lane. <i>Not sure what the dashed yellow line means though!</i>

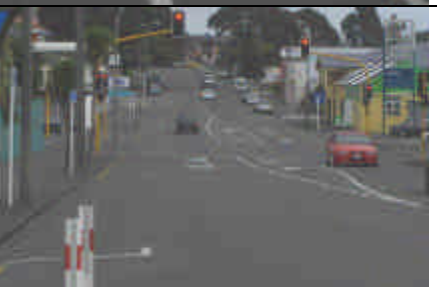
Looking towards Dawson Street	Lots of room for cycle lane, but could also reduce width of parking area. Reflectors are protecting a tree in front of STOS and are out of way of potential lane.

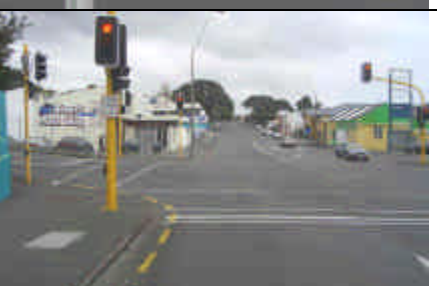
Dawson Street intersection.	Again, the Dawson Street intersection is tricky as the lights are fast cycling and it can be hard to judge your speed to ensure you go through on green. Also, left turning cars are often unaware of cyclists, sometimes watching right turning vehicles to see if they need to give way, and it can be hairy to ride straight through.

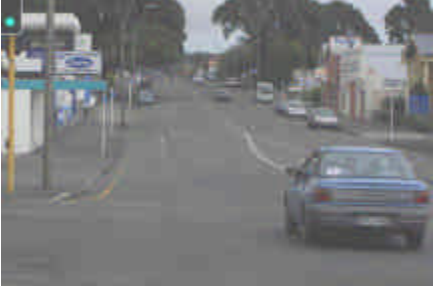
Location	Comments	Photos
Past Dawson Street Intersection	Lots of room for a cycle lane.

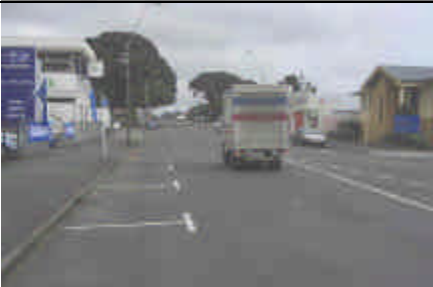
Between Dawson and Mt Edgecombe	Lots of room for a cycle lane.

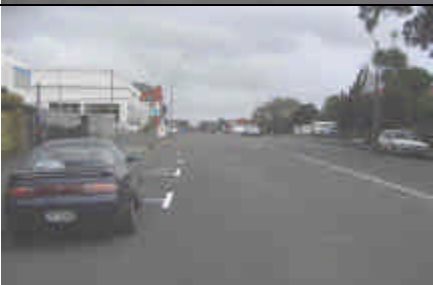
Towards Mt Edgecombe	Lots of room for a cycle lane.

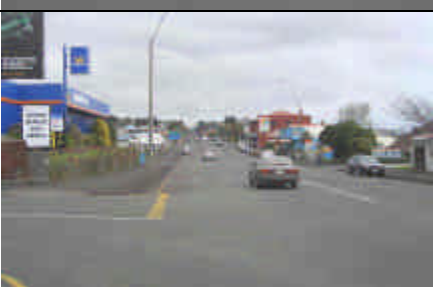
Mt Edgecombe intersection.	Lots of room for a cycle lane. And note the stop line painting so far into Devon Street and the painted over (or faded) lines behind it. This is actually the lines I show a close up of in the general section of this audit.

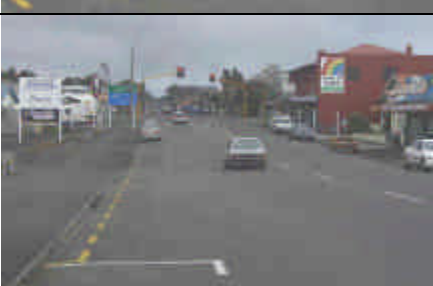
Towards Morley	Lots of room for a cycle lane.

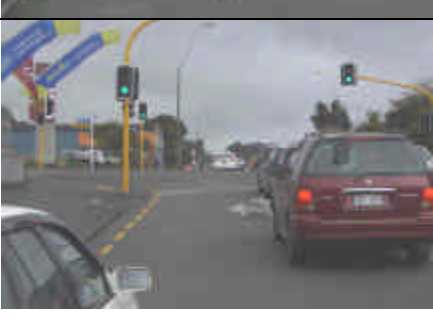
Morley Street intersection	This intersection in this direction is quite tricky as the lights are long cycling and the drivers get impatient and irritable, not seeing cyclists or even hurling abuse at them to help the boredom? Furthermore, as a cyclist at night I think that I don't weigh enough to trigger the mechanism and it seems to take forever to get a green... several times I have thought about walking to the pedestrian crossing button. Also, left turning cars are often unaware of cyclists, sometimes watching right turning vehicles to see if they need

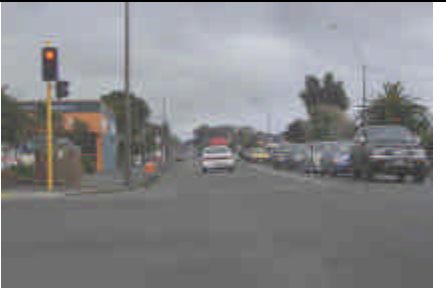
Location	Comments	Photos
	to give way, and it can be hairy to ride straight through.	
Morley Street intersection	When you do ride through it's slightly uphill and you are often given dirty looks or have near misses from the right turning oncoming traffic as you are slower than the other through traffic. Note also that there is lots of room for a cycle lane here.

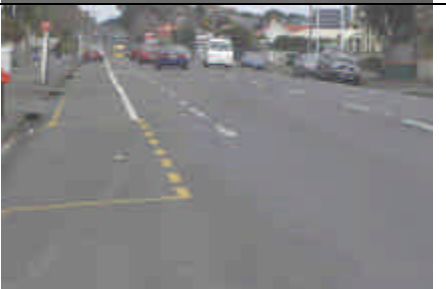
Past Morley at start of cycle lane.	Note how cycle lane just starts, past Fresha driveway, with no signage or warning to motorists. Note also how faded the cycle stencil is, it's hardly visible in this photo.

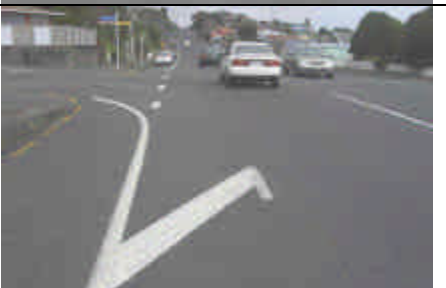
Cutfield Road Intersection	Confusing chevron and no lane markings through intersection, inconsistent with other locations.

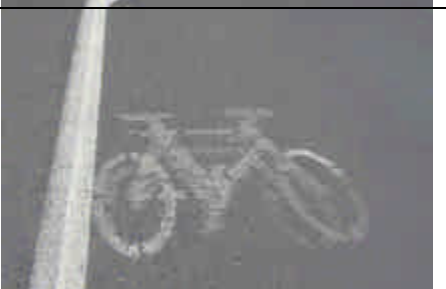
Just past Cutfield	Another faded and doubled cycle stencil.

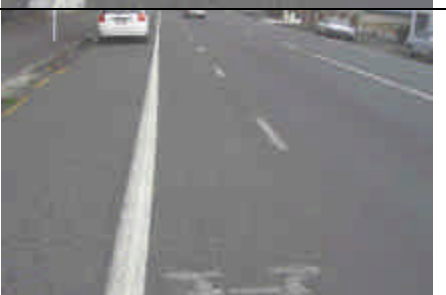
Past Cutfield	Parking solid line re-painted but dashed cycle lane markings faded (does not show as well in photo as actual).

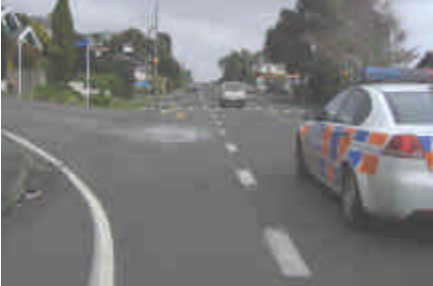
Location	Comments	Photos
Belt Road intersection	Inconstant lane marking though intersection. Most likely not intended as cycle lane but used that way.

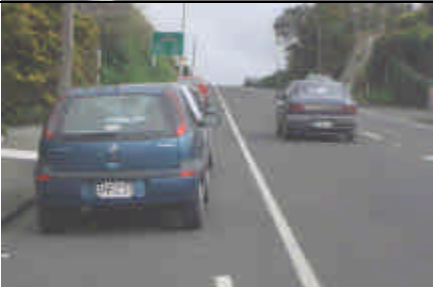
Heading up hill towards Lorna Street	Lots of room for cycle lane if painting adjusted.

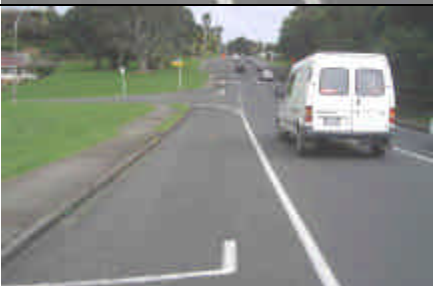
Lorna Street Intersection	Some room for cycle lane marking.

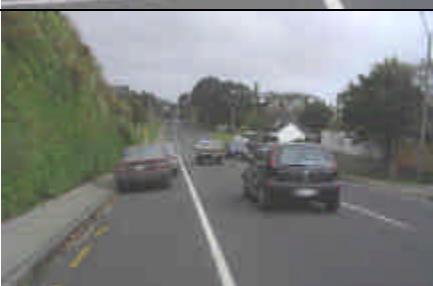
Between Lorna and Doone	Some room for cycle lane marking.

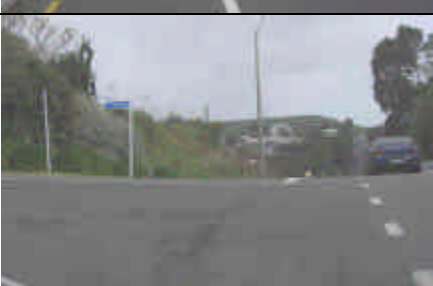
Doone Street Intersection	Effectively a cycle lane here, so it would be nice to paint one. Note how far into road yield lines are painted. When cars overshoot them, it is quite scary for cyclists. There are also problems here with people turning right and not seeing the cyclist bridging the hill.

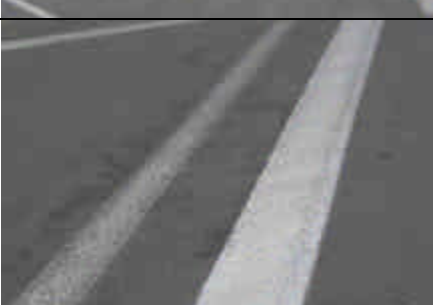
Doone Street Intersection	Close up of faded lines above.

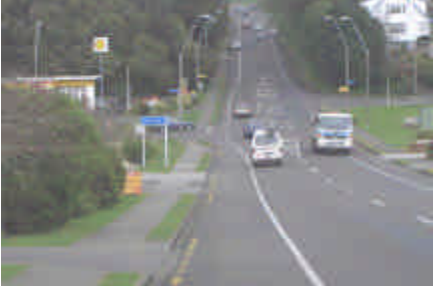
Location	Comments	Photos
Down hill towards Seaview Road	Some room for a cycle lane, but not much. Parking areas only really used during pub overflow hours. Intersection tricky as people are often in a hurry to turn left off Lawry onto Devon, then right onto Seaview and don't see the cyclists.

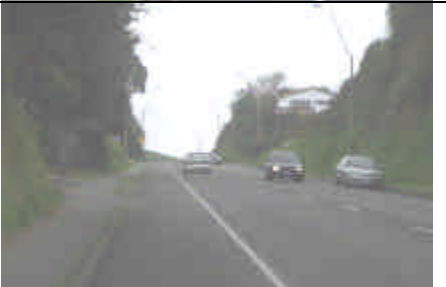
Up hill past Seaview Road	Some room for a cycle lane, but not much. Is parking necessary here?

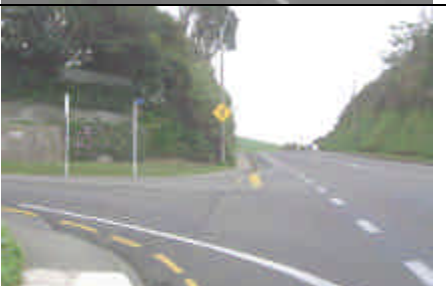
Bayly Road Intersection	Some room for cycle lane, note far out stop markings, note inadequate room for car parking past intersection but ample room for cycle lane.

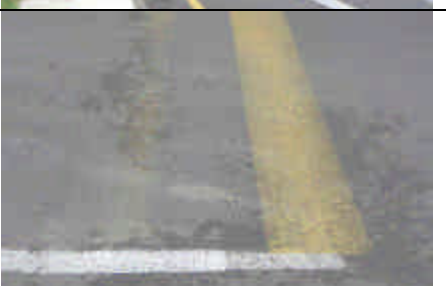
Bayly Street Intersection	Close up of faded lines above, and no painting of first line.

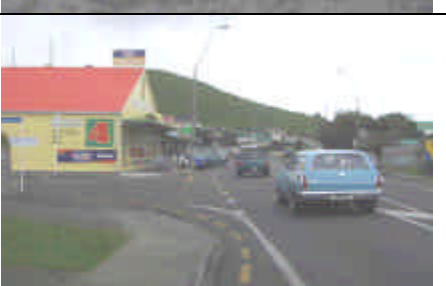
Stuart Street Intersection	Very tight here for cyclists. Have had close calls from turning traffic not seeing me (left turning traffic off Devon, left or right turning traffic off Stuart).

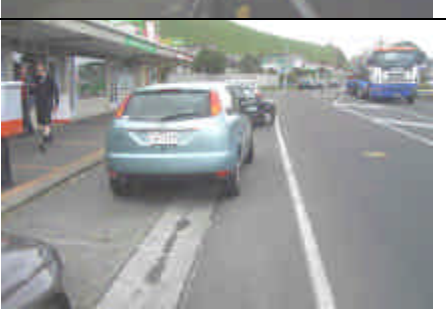
Blagdon Shops	Biking past here can be quite crazy as inattentive motorists often park badly or far right and then pull out without looking for cyclists. I have had close calls with car doors, people running across and cars pulling out unexpectedly. I am not sure what could be done to improve this but do think that improved motorist awareness with road signs and painted cycles on the road would help. Note also at this location that there is essentially a cycle lane; it's just not fully marked. It would be quite simple to add lane painting here.

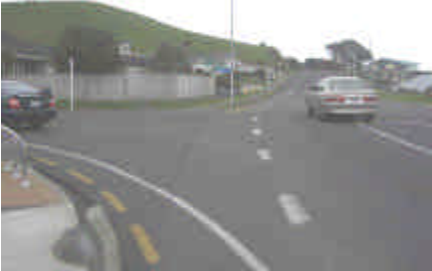
Location	Comments	Photos
Blagdon Road Intersection	Lots of room for a cycle lane in this area

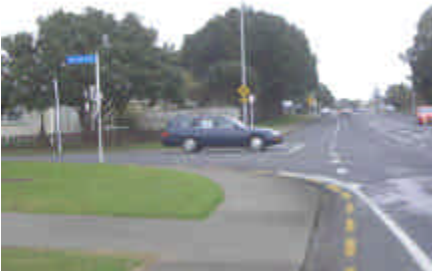
Belair Avenue Intersection	Pinched area for cyclists but could be improved. Lots of room beyond intersection for cycle lane.

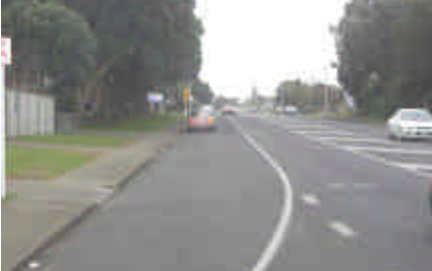
Past Belair Avenue	Lots of room for cycle lane.

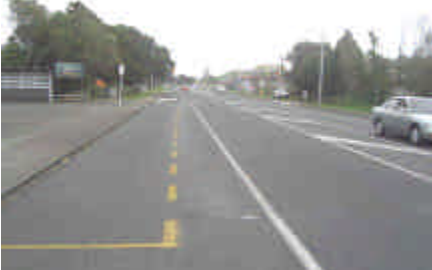
In front of Spotswood College	Lots of room for cycle lane.

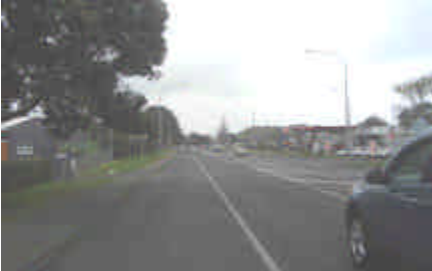
Approaching Pioneer Road intersection.	In rush hour traffic, it can be quite difficult for me to get from the shoulder (cycle area) to the right hand turning lane for Pioneer Road. I have used the Spotswood College pedestrian crossing at times. I mention this not as part of potential improvements only to increase awareness of the issues hesitant cyclists face.

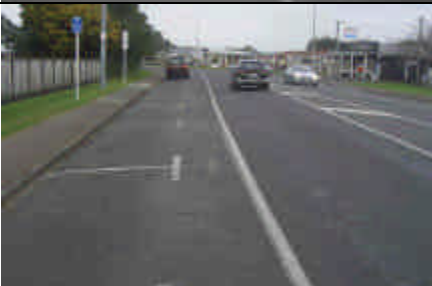
Past Pioneer Road intersection	I note that the contractor is reducing the size of these parking bays. This creates room for a cycle lane. Is that the intention?
