4058

REFRESH

FINISH DETAILS

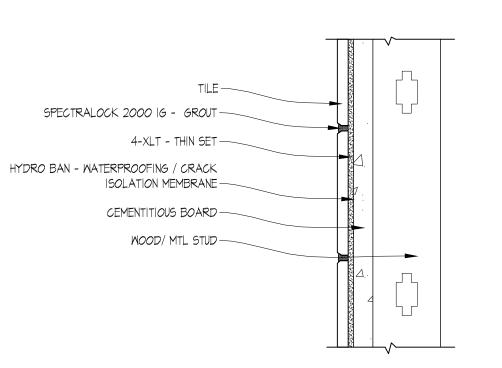
07 RESTROOM TILE GROUT DETAIL

THIS DETAIL IS BASED ON LATICRETE DETAIL W244C-I2 MR-I / GR-2 / WM-I

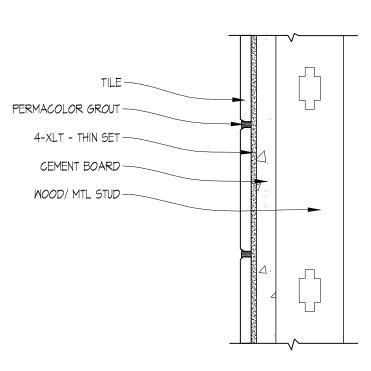
06 DINING AREA TILE DETAIL SCALE:" = 6"= 1'-0"

THIS DETAIL IS BASED ON LATICRETE DETAIL W244C-I2 MR-I / GR-I

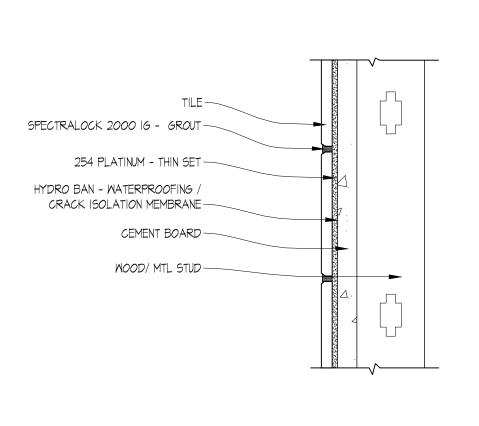
05 KITCHEN TILE GROUT DETAIL

THIS DETAIL IS BASED ON LATICRETE DETAIL W244C-I2 MR-2 / GR-2 / WM-I

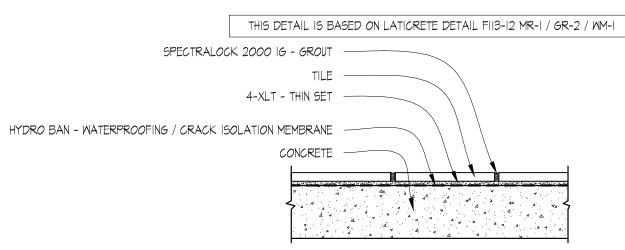
08 DINING AREA TILE GROUT DETAIL
SCALE:1 1/2"= 1'-0"

THIS DETAIL IS BASED ON LATICRETE DETAIL FII3-12 MR-1 / GR-1 PERMACOLOR GROUT ---4-XLT - THIN SET HYDRO BAN - WATERPROOFING / CRACK ISOLATION MEMBRANE
